Ben Keys  
Consulting Arborist  
AQF 5 | Melbourne Polytechnic

**Arboricultural Impact Assessment**

Indigo Shire Council solar array  
2 Kurrajong Way,  
Beechworth, 3747

February 27, 2023

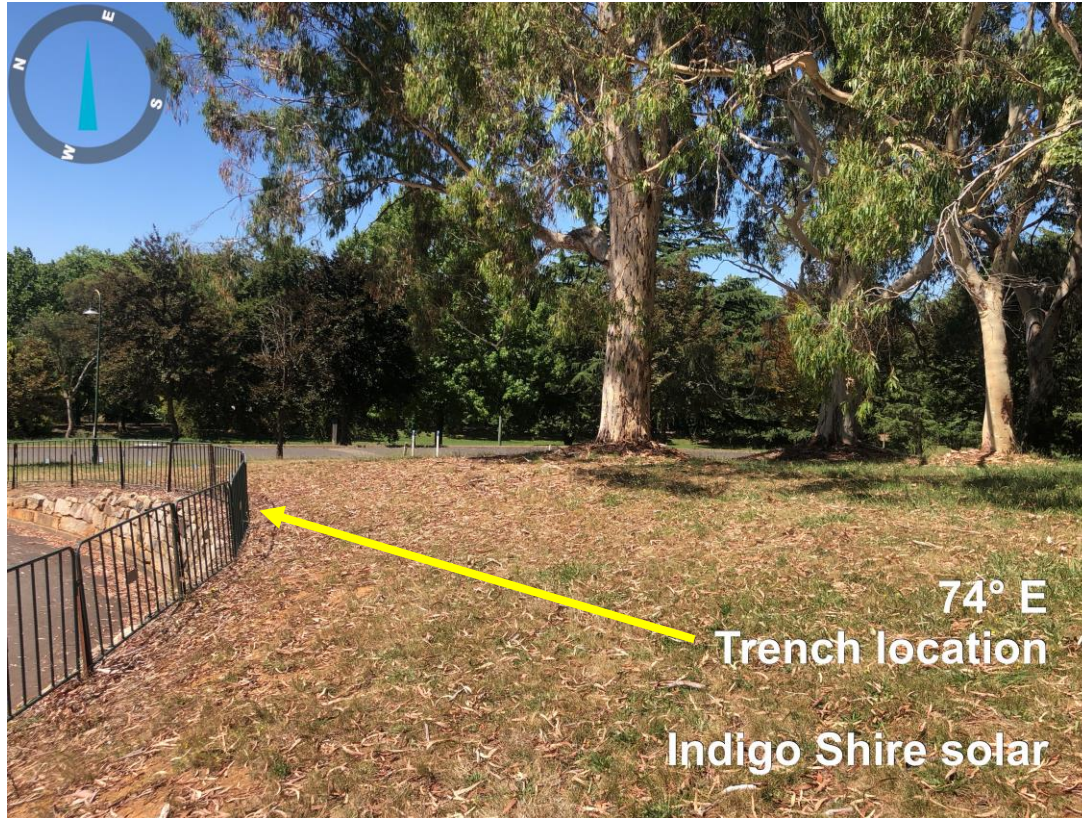
5. Tree 1 is a high-value remnant *Eucalyptus mannifera*, located 8.5m from the embankment. Impact to Tree 1 will result from cable trenching at the edge of the retaining wall. Given no tree roots can exist beyond the edge of this wall, we are satisfied minor excavation in this area will not significantly impact Tree 1's health and we expect this tree to remain viable.

Trench 600mm deep to be excavated along edge of wall near Tree 1. Tree roots cannot extend beyond wall, so any impact from trenching at this location will be minimal.

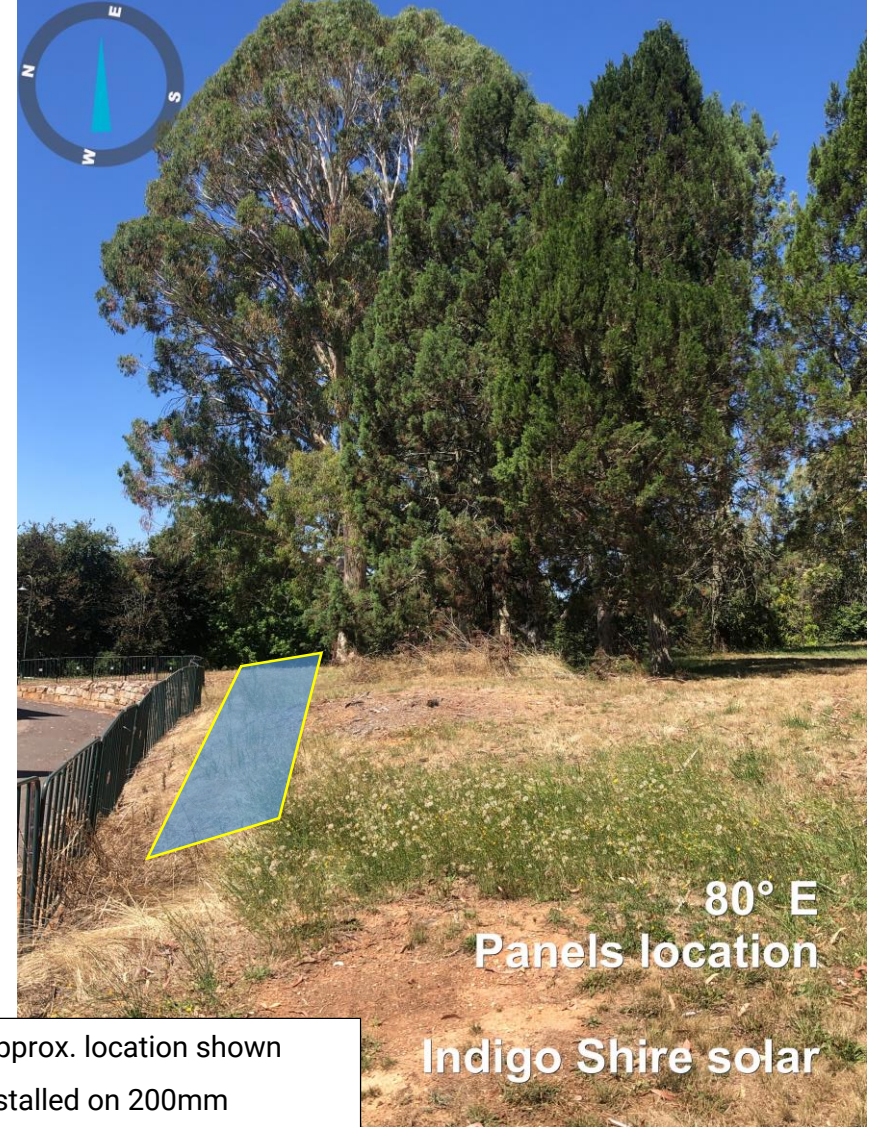
Solar panels (approx. location shown above) to be installed on 200mm diameter concrete posts. Minor impacts (less than 10%) expected to Trees 4-6.

9. All excavation works must be undertaken with relatively lightweight machinery (no heavy excavators), unless these larger machines can work from outside tree TPZ areas (excavate using long booms).

10. We understand it will be important that the final solar array is installed at a consistent height, despite the undulating ground on top of the embankment. This must be achieved by varying post heights/installation depth – not via earthworks to level the surface or via any site cut/fill across the TPZ areas of affected trees.

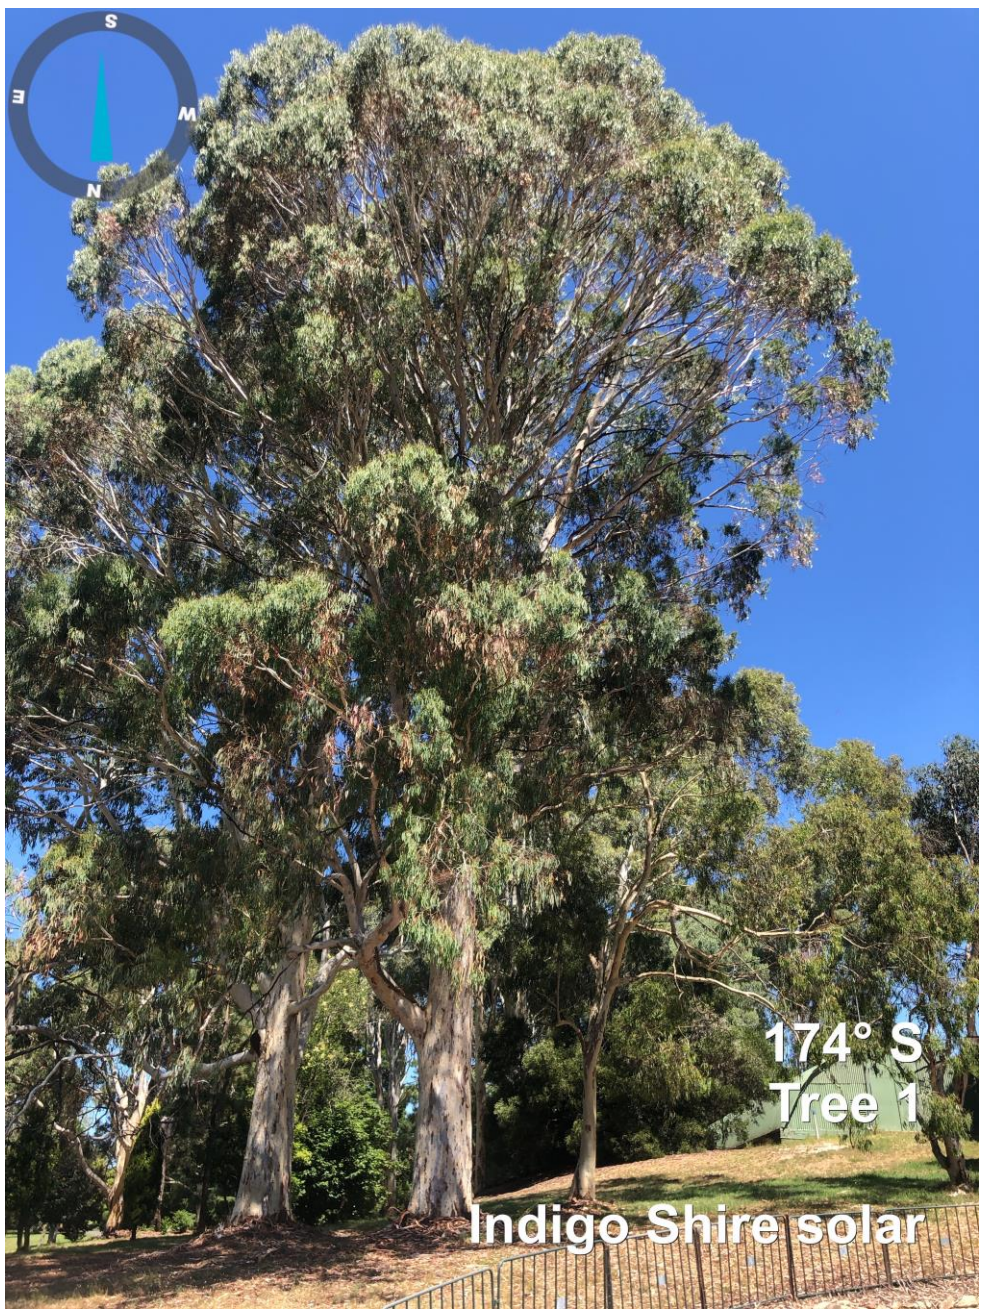
### TREE 1 *Eucalyptus mannifera* Brittle Gum

B. Name	ULE	DBH	TPZ	DAB	SRZ
<i>E. mannifera</i>	50+	1.11m	13.32m	1.22m	3.60m
Height	Spread	Health/structure	Age	Arb. Value	Impact
22m	16m	Good, good	Maturing	High	Minor <10%

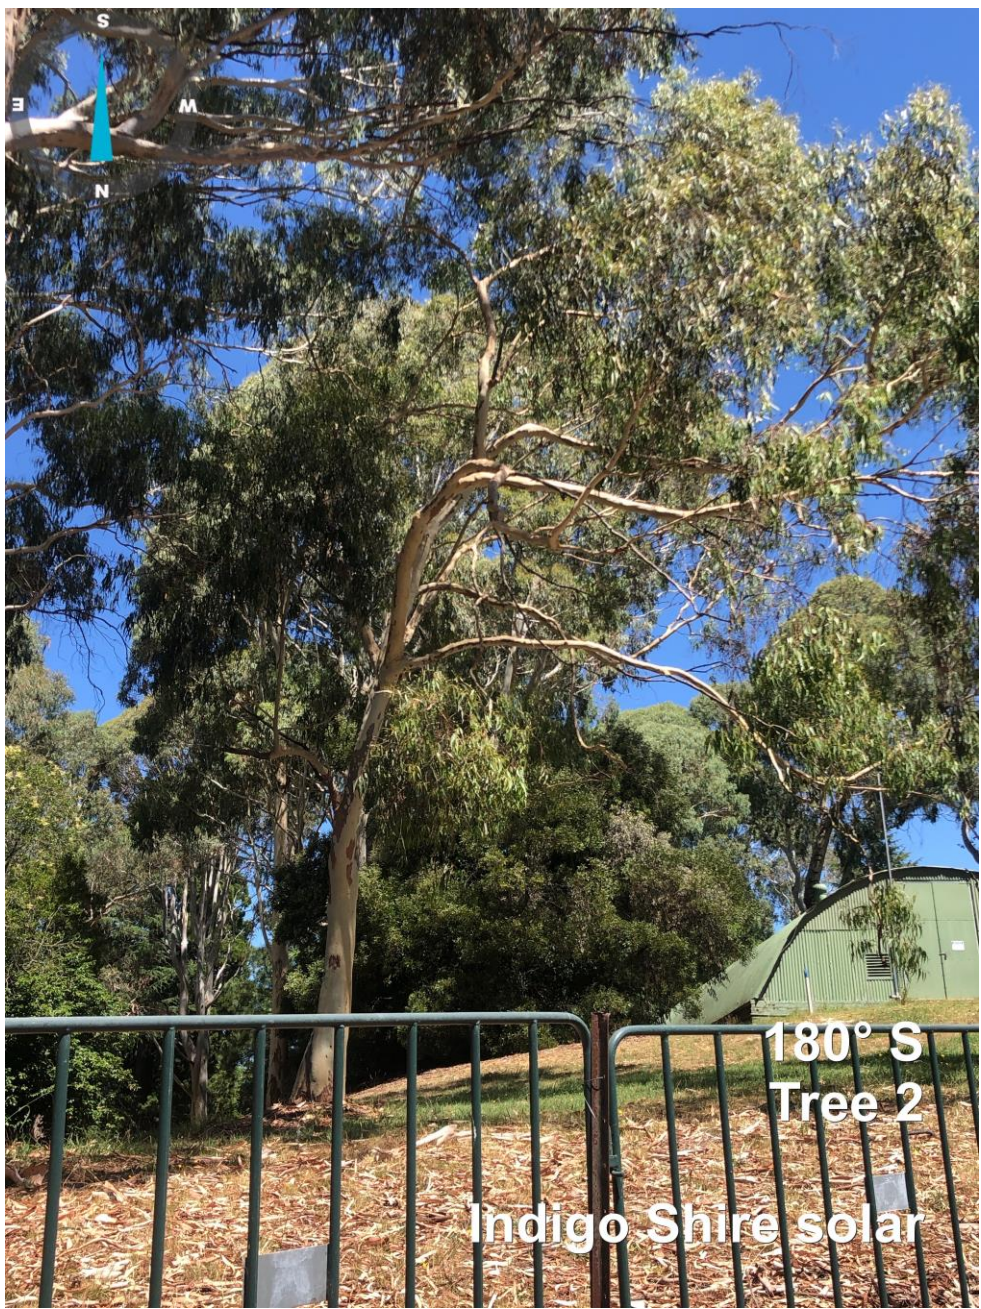
**TREE 2 *Corymbia citriodora***

B. Name	ULE	DBH	TPZ	DAB	SRZ
<i>C. citriodora</i>	20-50	0.40m	4.80m	0.56m	2.59m
Height	Spread	Health/structure	Age	Arb. Value	Impact
9m	8m	Good/average	Maturing	Medium	Nil

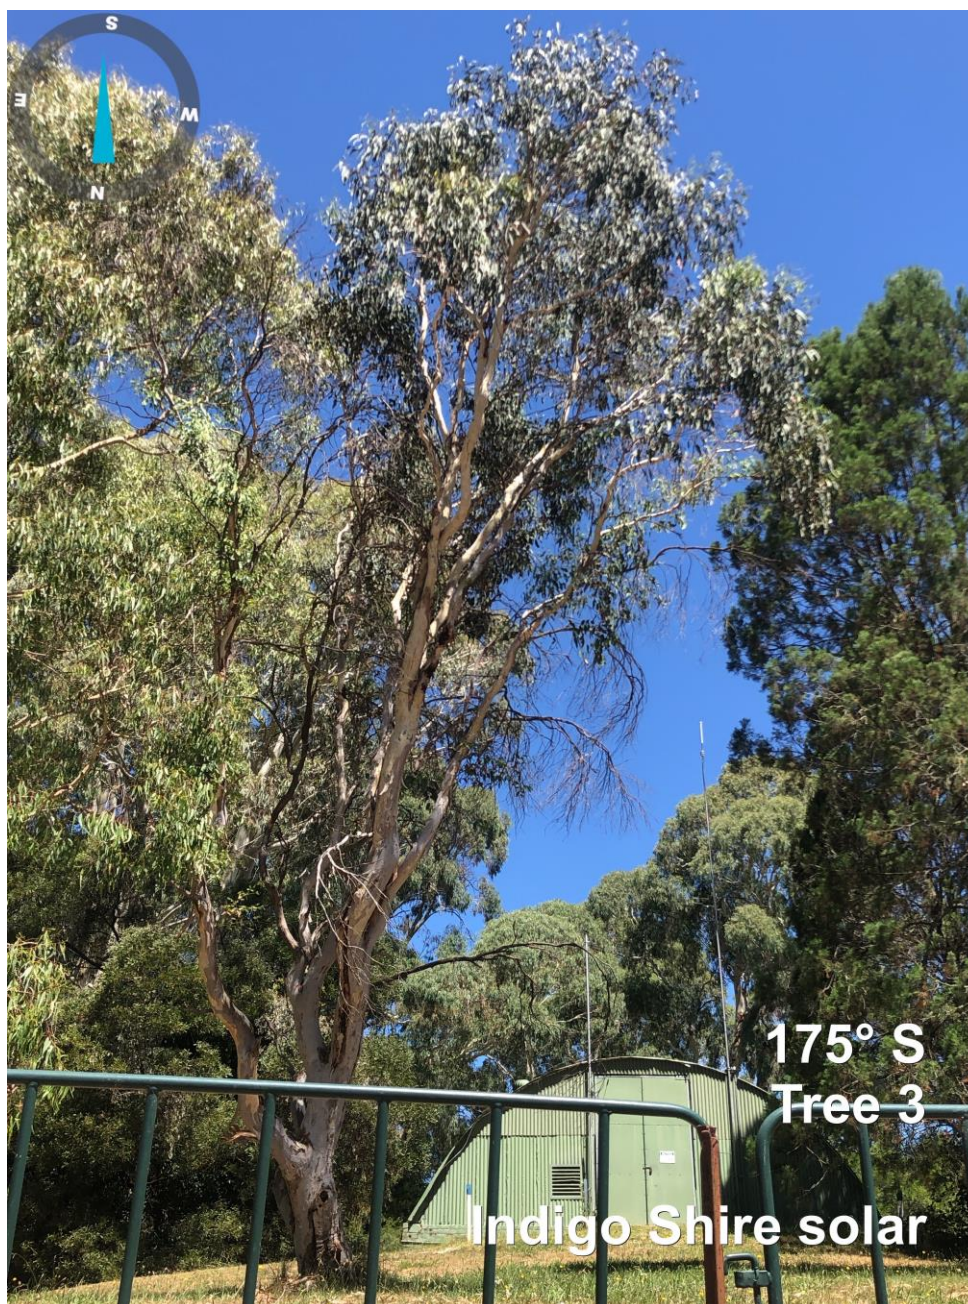
**TREE 3 *Eucalyptus species***

B. Name	ULE	DBH	TPZ	DAB	SRZ
<i>Eucalyptus sp.</i>	0-10	0.21, 0.42m	5.64m	0.47m	2.41m
Height	Spread	Health/structure	Age	Arb. Value	Impact
7m	4m	Poor/poor	Over-mature	Low	Nil

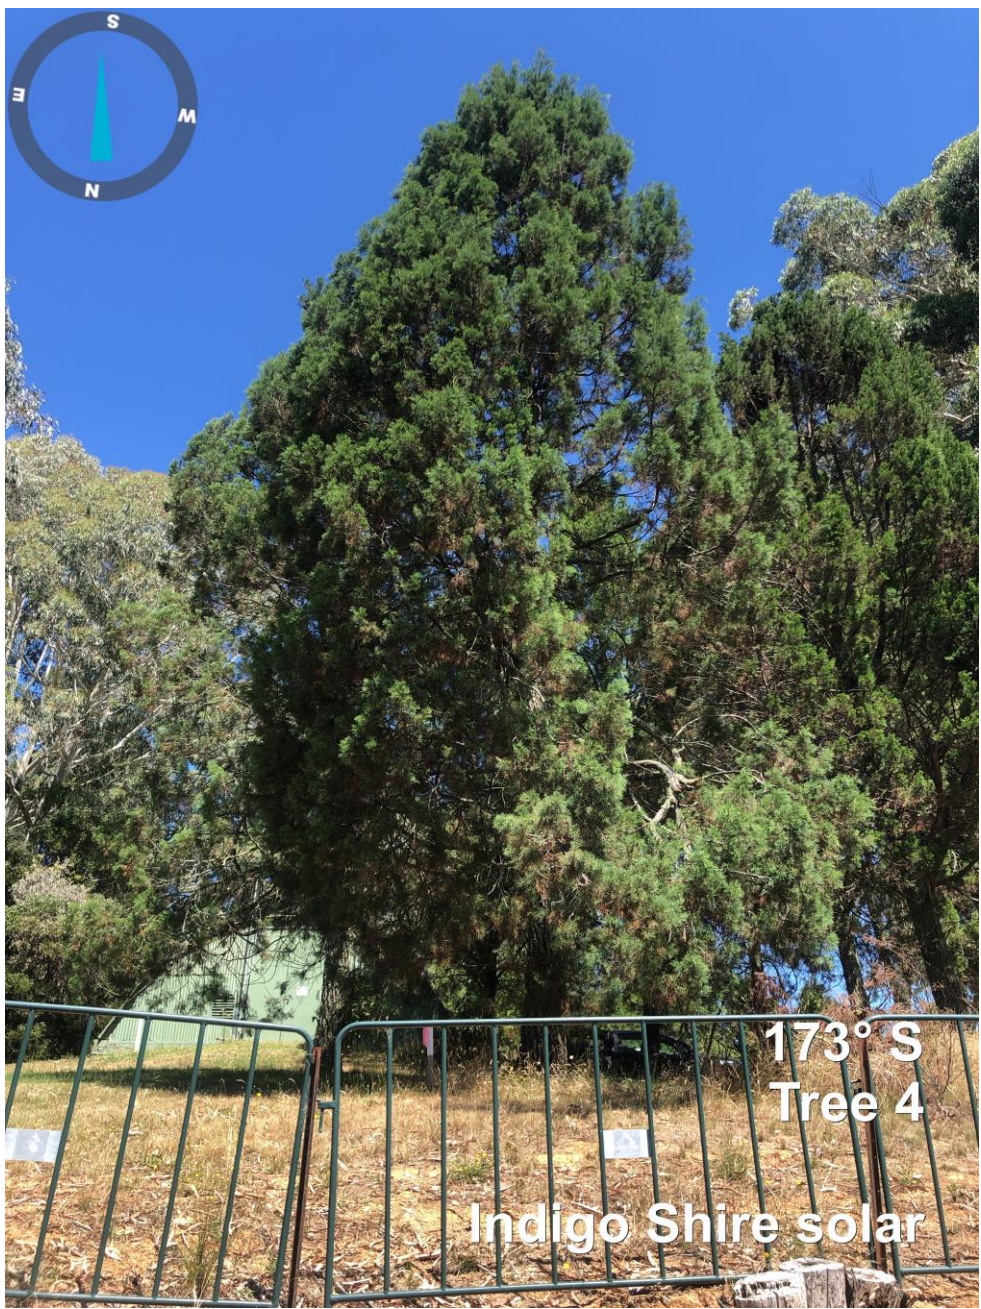
**TREE 4 *Callitris endlicheri***

6. Trees 2 and 3 are located a sufficient distance from the wall so as not to be affected by trenching.
7. Trees 4 and 5 are maturing *Callitris endlicheri*, located 5-7m from the edge of the embankment. Impact to these trees will result from post-holes dug for panel supports. Given the relatively small size of these post-holes (200mm diameter) we are satisfied this minor excavation will not negatively affect the health of Trees 4 and 5 and they will remain viable.

B. Name	ULE	DBH	TPZ	DAB	SRZ
<i>C. endlicheri</i>	20-50	0.38m	4.56m	0.47m	2.41m
Height	Spread	Health/structure	Age	Arb. Value	Impact
7m	5m	Good/good	Maturing	Medium	Minor <10%

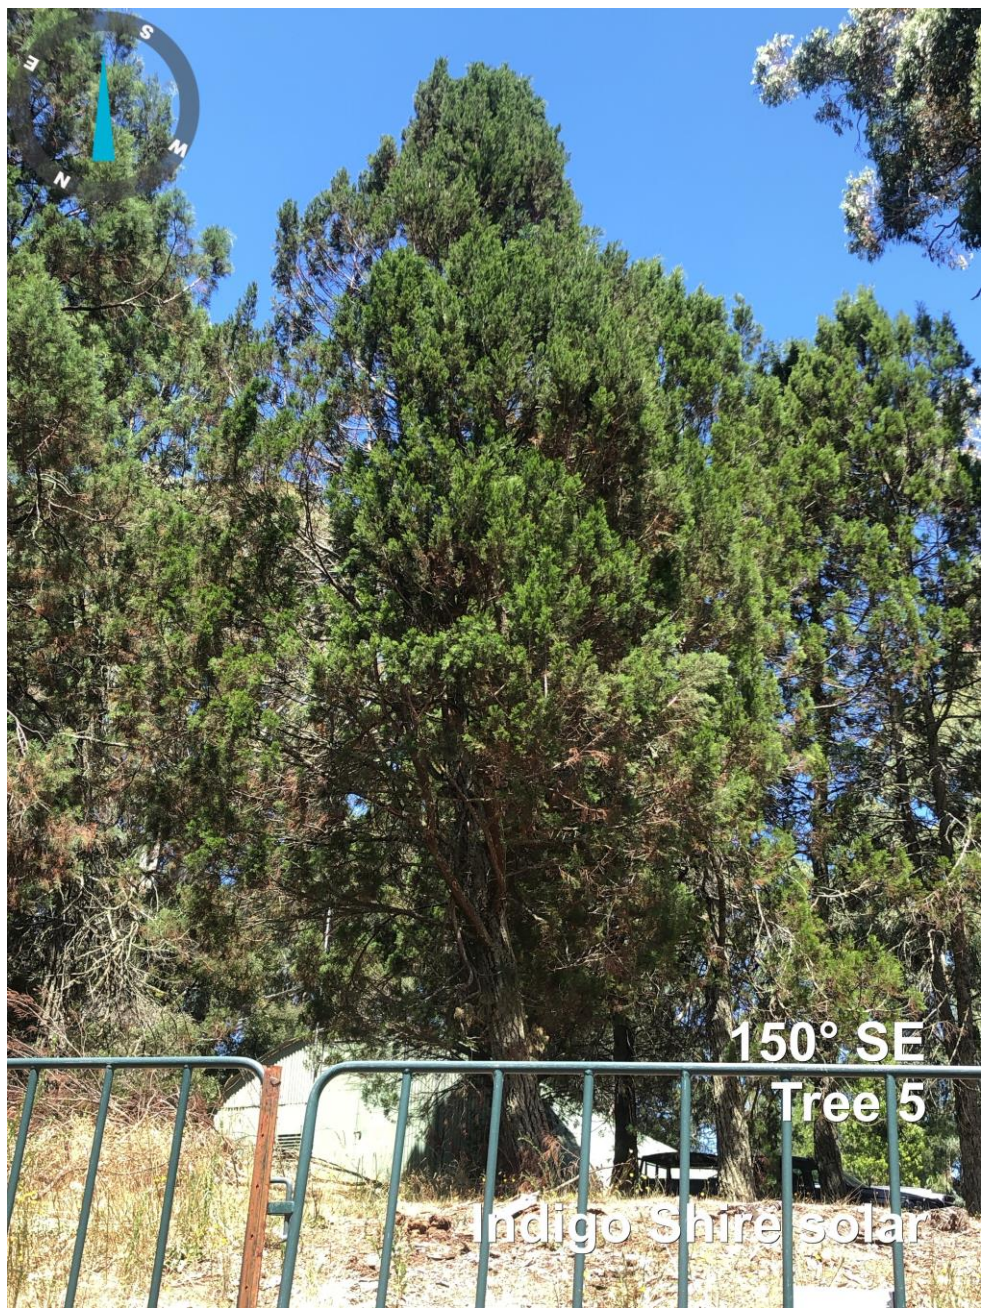
**TREE 5 *Callitris endlicheri***

B. Name	ULE	DBH	TPZ	DAB	SRZ
<i>C. endlicheri</i>	20-50	0.32m	3.84m	0.38m	2.20m
Height	Spread	Health/structure	Age	Arb. Value	Impact
6m	4m	Average/average	Maturing	Medium	Minor <10%

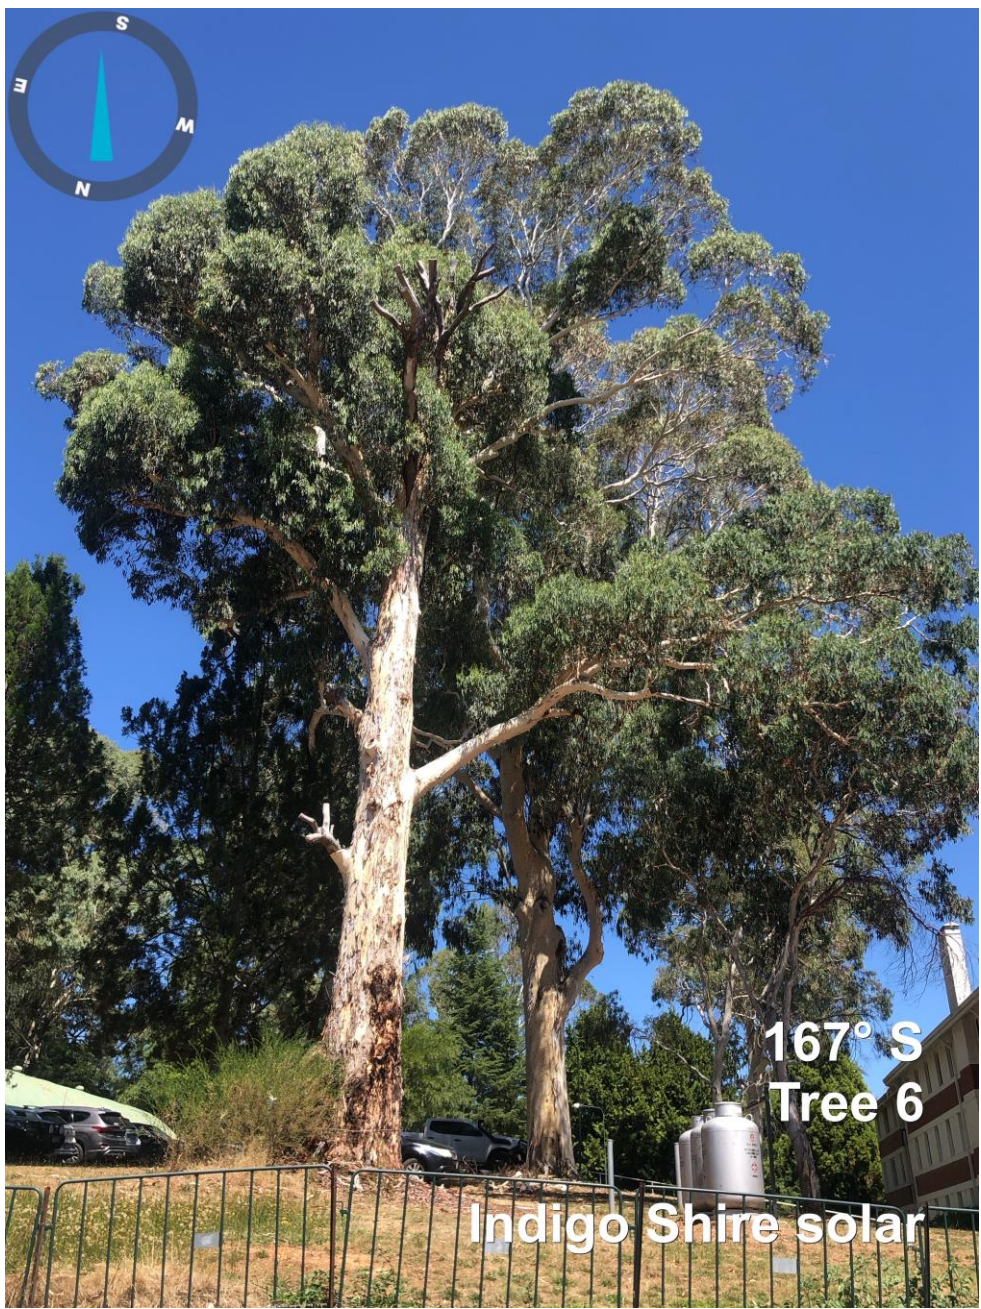
**TREE 6 *Eucalyptus mannifera* Brittle Gum**

8. Tree 6 is another high-value remnant *Eucalyptus mannifera*, located 11m from the embankment. Impact to Tree 6 will also result from post-hole excavation. Again, these are

minor excavation works in comparison to the large TPZ area of Tree 6, so we are satisfied this tree will also remain viable, with expected impacts well under 10%.

B. Name	ULE	DBH	TPZ	DAB	SRZ
<i>E. mannifera</i>	50+	1.54m	15.0m	1.72m	4.16m
Height	Spread	Health/structure	Age	Arb. Value	Impact
18m	10m	Average/average	Maturing	High	Minor <10%
